NBSIR 82-2593

Investigation of Construction Failure of the Riley Road Interchange Ramp, East Chicago, Indiana

October 1982

N. J. Carino
H. S. Lew
W. C. Stone
R. M. Chung

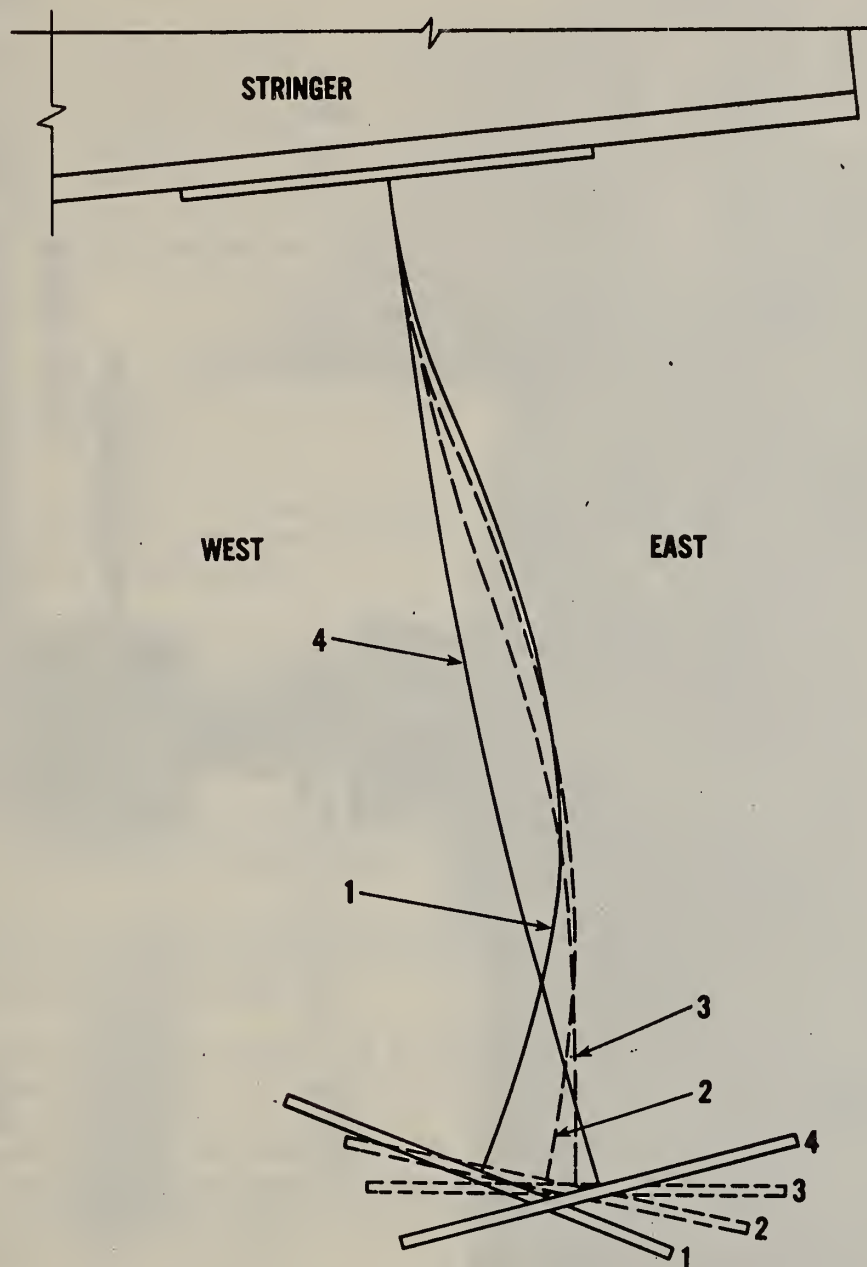
Figure 6.7 Schematic representation of the change in the deformed shape of the crossbeam web as the bottom flange translates eastward

A second analysis was performed in which the U-heads were assumed to provide no rotational restraint to the lower flange of the crossbeam. All other boundary conditions and applied loads were the same as in the first analysis. The resulting deflected shape is shown in figure C.3. This change in curvature of the crossbeam web agrees with the changes described in figure 6.7.

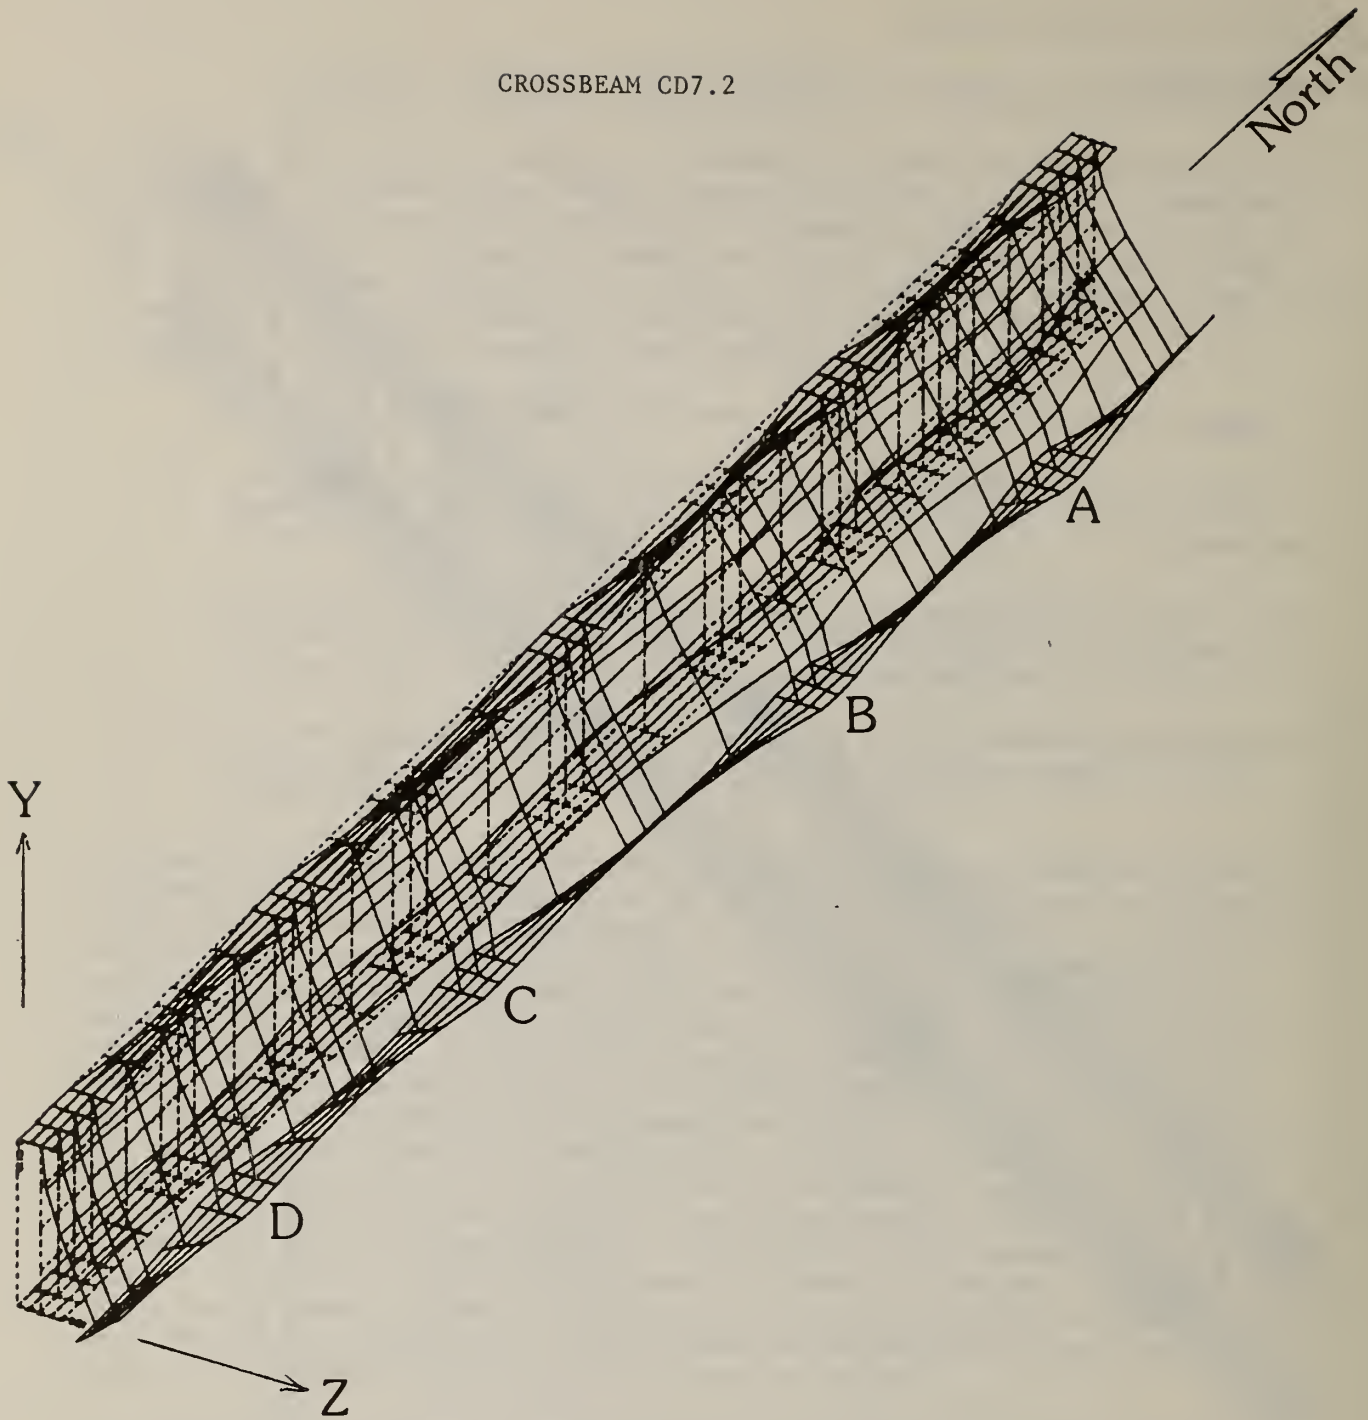
1. The stringer reaction points were assumed to act as fixed supports.
2. The vertical reactions from the U-heads were applied as a distributed load to the web of the crossbeam across the contact width of the U-head top plate.
3. The calculated longitudinal deformations of the crossbeam along the axis of the ramp (figure 6.6) were applied as lateral displacements of the lower flange of the crossbeam at the supporting U-heads.
4. For the initial analysis the top plates of the U-heads were assumed to provide restraint against rotation of the lower flange at the support points.

Figure C.2 Deflected shape of crossbeam for analysis #1. U-head supports are assumed to provide rotational resistance to bottom flange of crossbeam. Dotted lines indicate original position of undeformed beam.

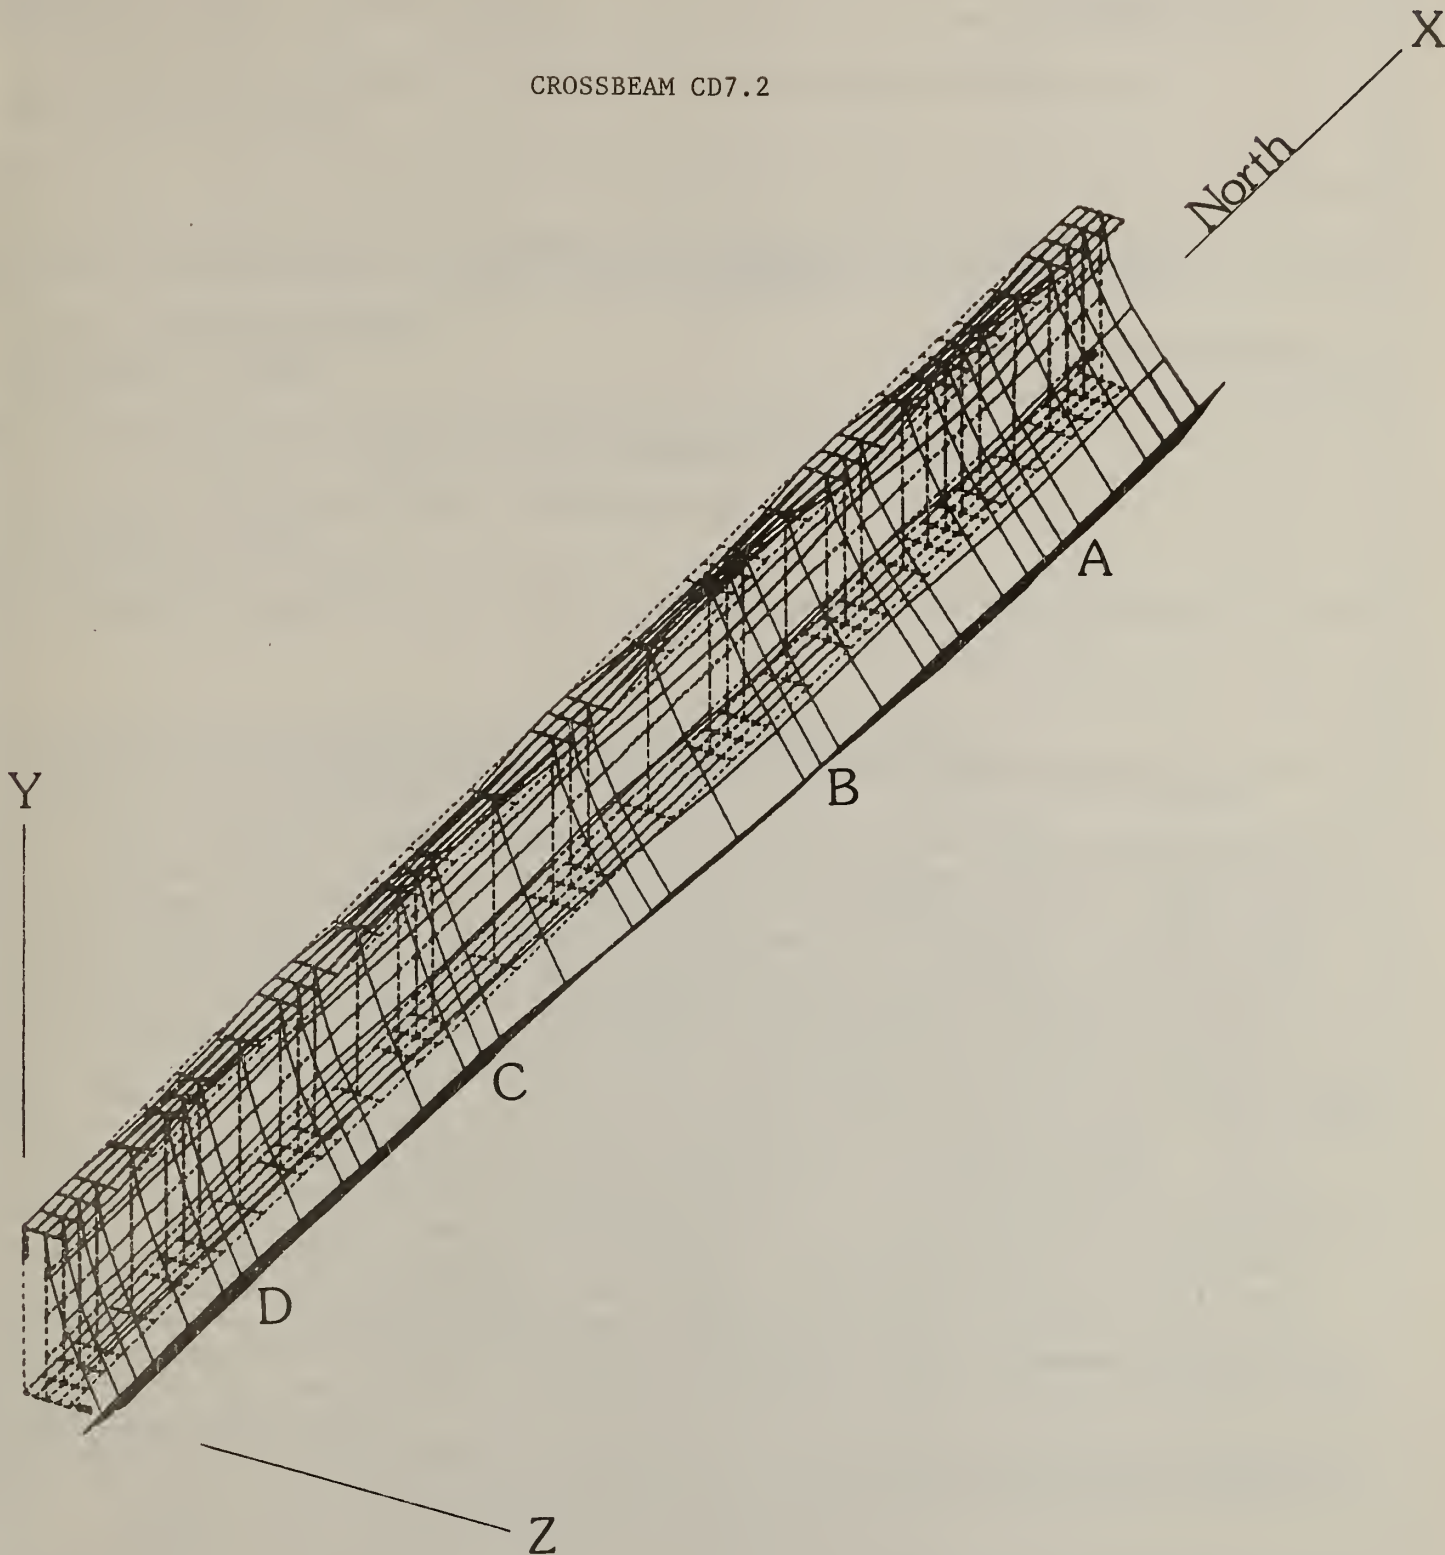
Figure C.3 Deflected shape of crossbeam for analysis #2. U-head supports are assumed to provide no rotational resistance to bottom flange of crossbeam. Dotted lines indicate original position of undeformed beam.
